**Basalt Regional Library District Board of Trustees Meeting**  
**Monday, October 16, 2023, 5:15 PM**  
**Basalt Library Conference Room and**  
**Zoom Meeting, see [BRLD Website Calendar for Link](#)**

## “Full” Capital Replacement Plan

## Basalt Regional Library Basalt, CO

**1 OVERALL ROOF PLAN AND SITE PLAN**  
SCALE: 1/16" = 1'-0"

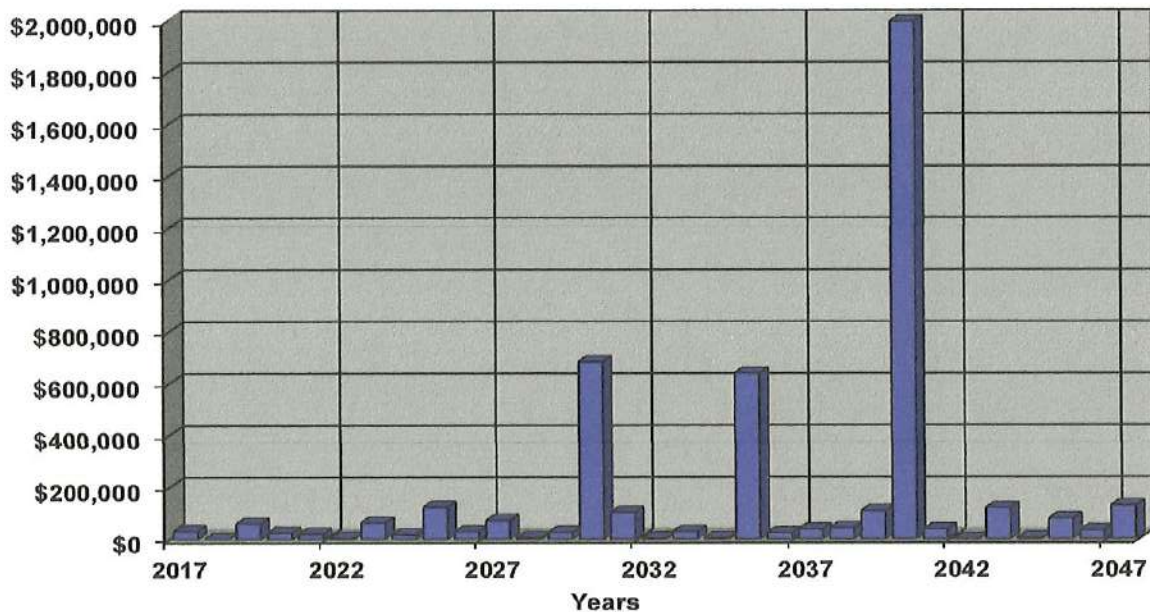
Figure 1

While this Capital Replacement Plan looks forward 30 years, we have no expectation that all these expenses will all take place as anticipated. This Plan needs to be updated annually because we expect the timing of these expenses to shift and the size of these expenses to change. We do feel more certain of the timing and cost of near-term expenses than expenses many years away. Your *first five years* of projected Reserve expenses total \$133,421. Adding the next five years, your *first ten years* of projected Reserve expenses are \$368,126. Please be aware of your near-term expenses, which we are able to project more accurately than the more distant projections.

**Annual Reserve Expenses**

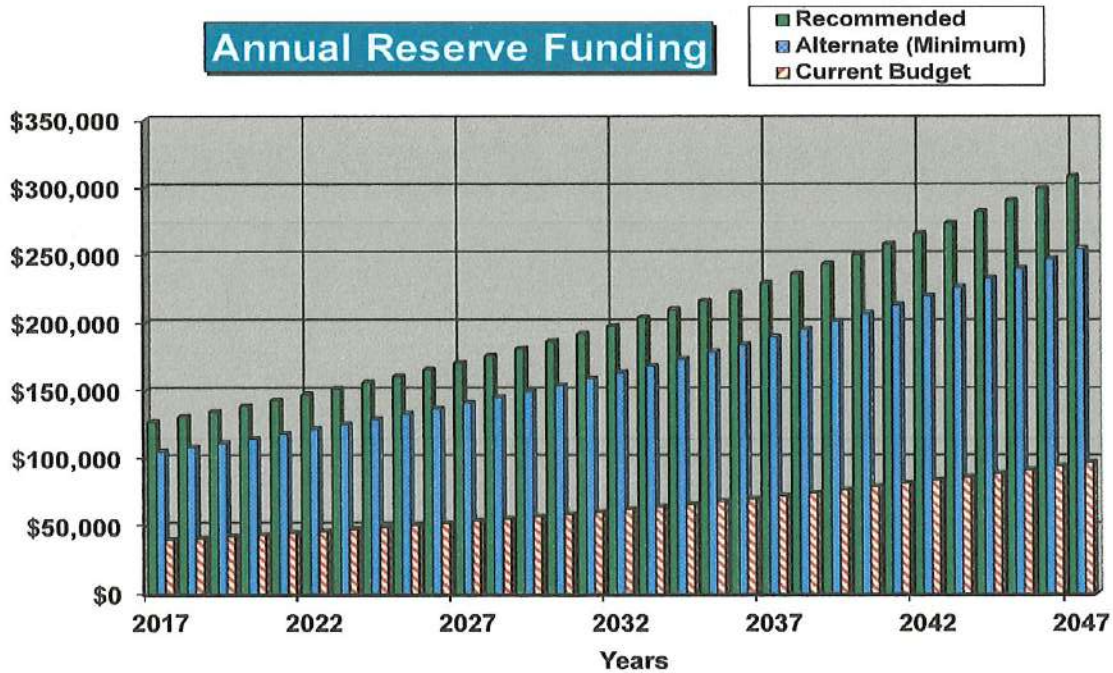
Figure 2

Based on your current Percent Funded and your near-term and long-term Reserve needs, we are recommending budgeted contributions of \$127,000/year this Fiscal Year. The overall 30-yr plan, in perspective, is shown below. This same information is shown numerically in both Table 5 and Table 6.

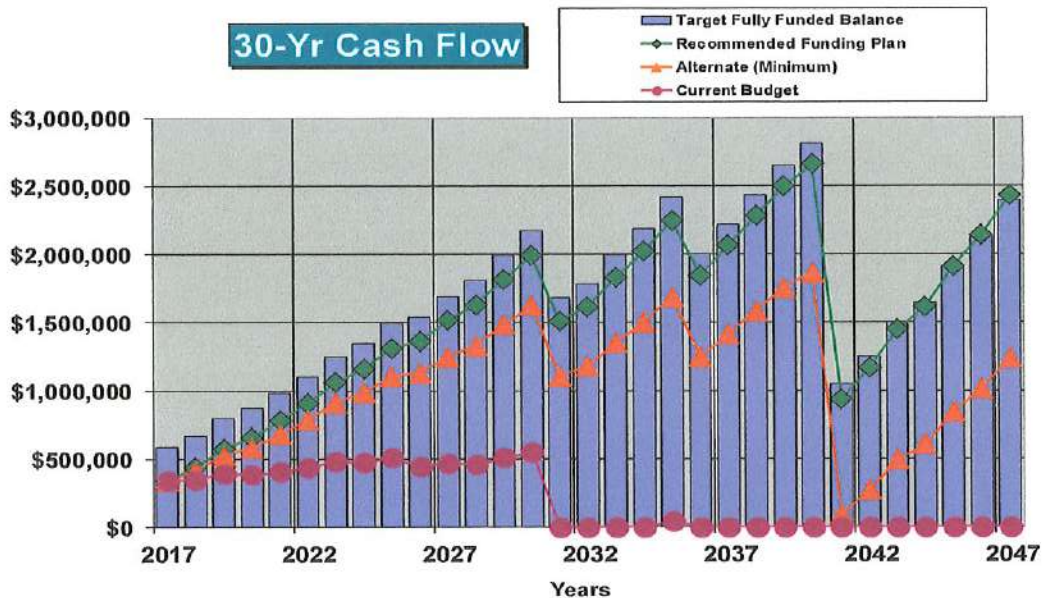
Figure 3

The following chart shows your Reserve balance under our recommended Full Funding Plan, an alternate Baseline Funding Plan, and at your current budgeted contribution rate, compared to your always-changing Fully Funded Balance target.

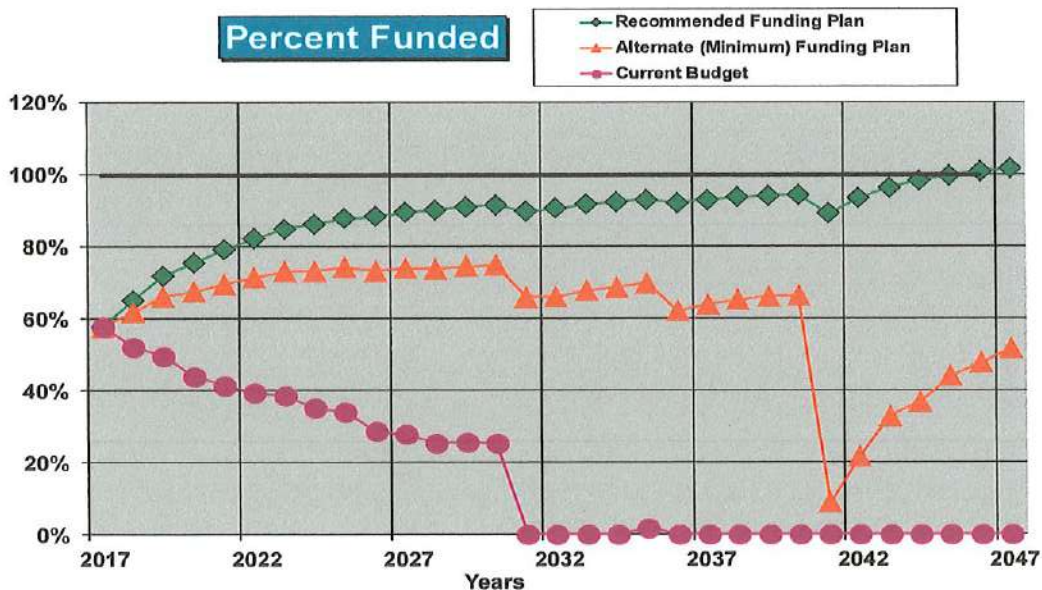
Figure 4

This figure shows this same information, plotted on a Percent Funded scale.

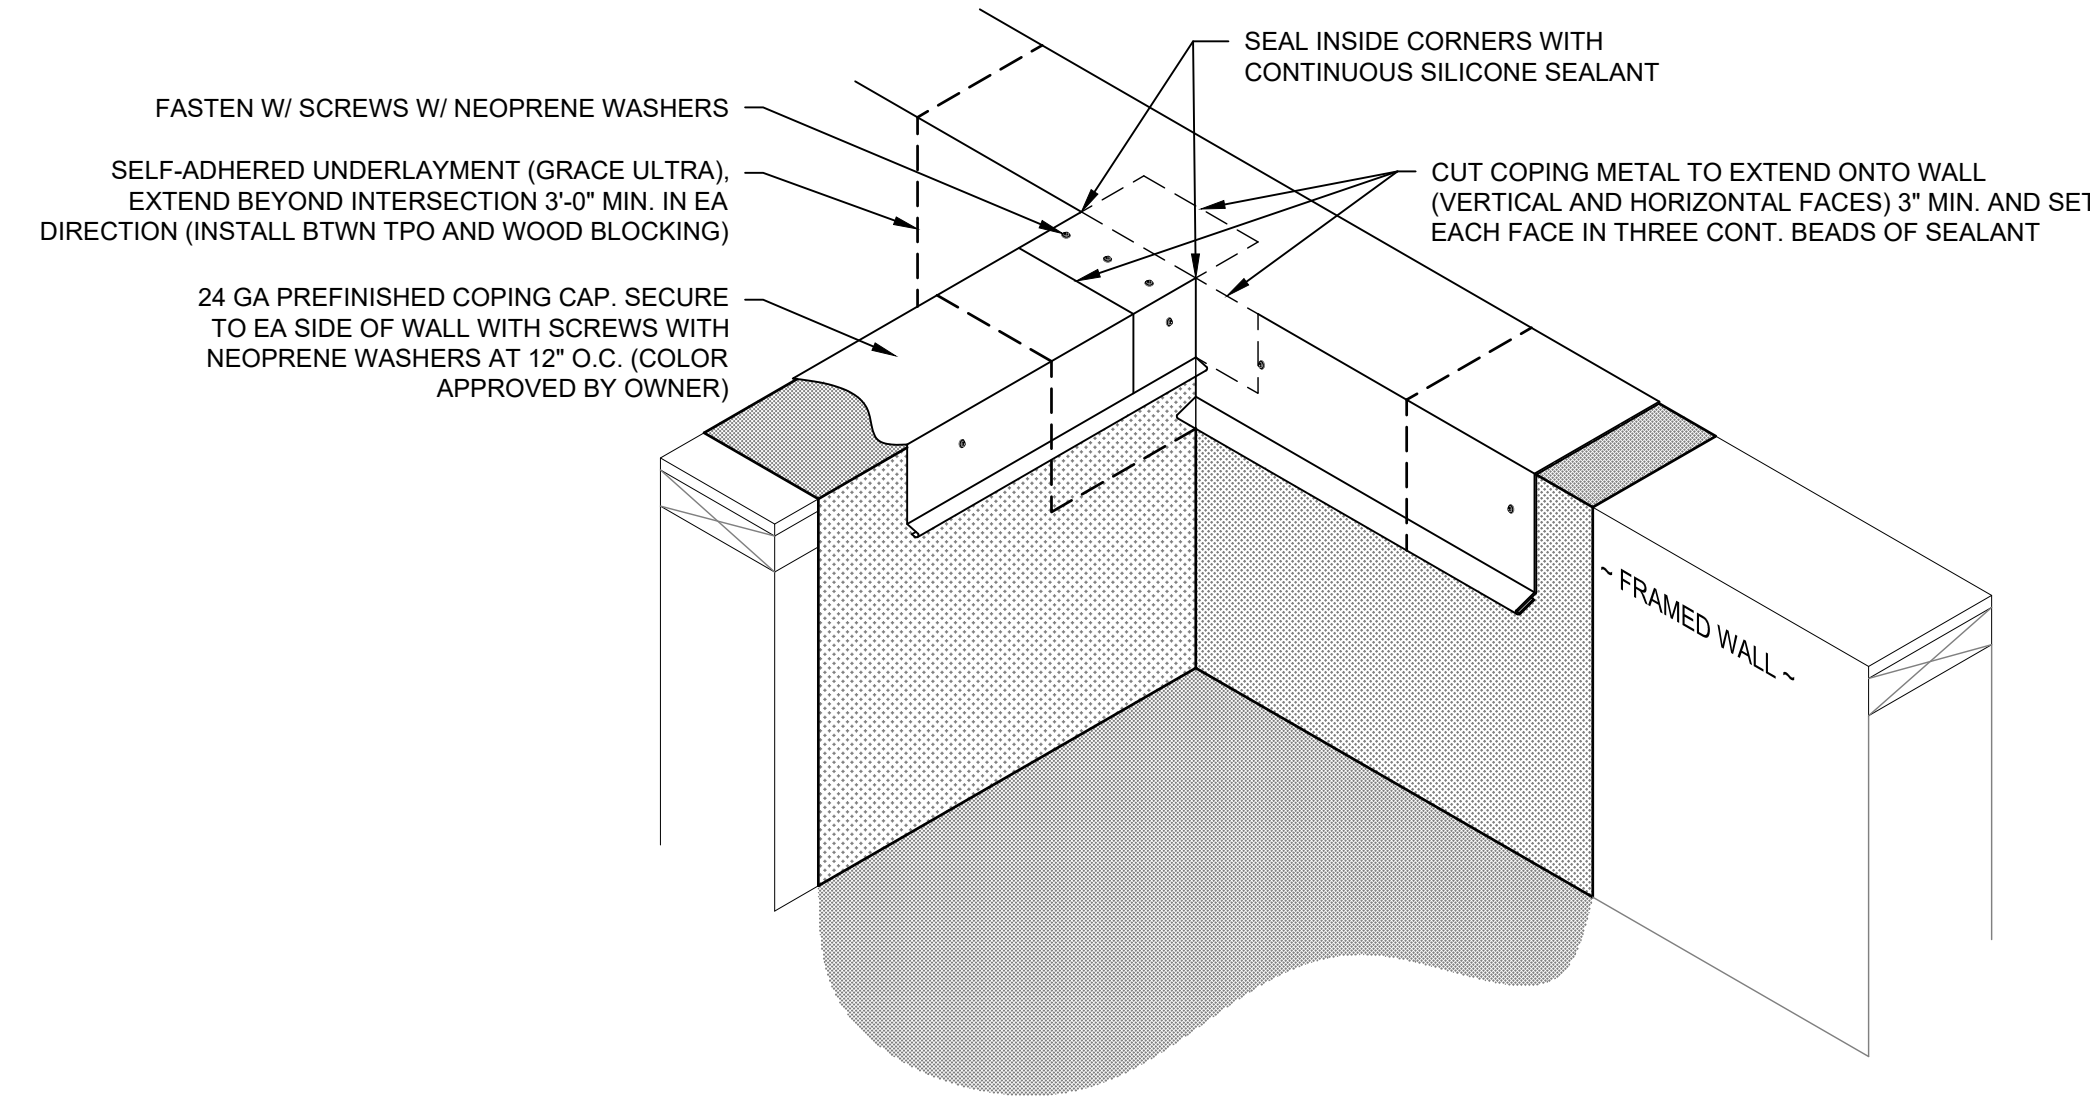
4 Detailing at Coping Intersection  
SCALE: N.T.S.

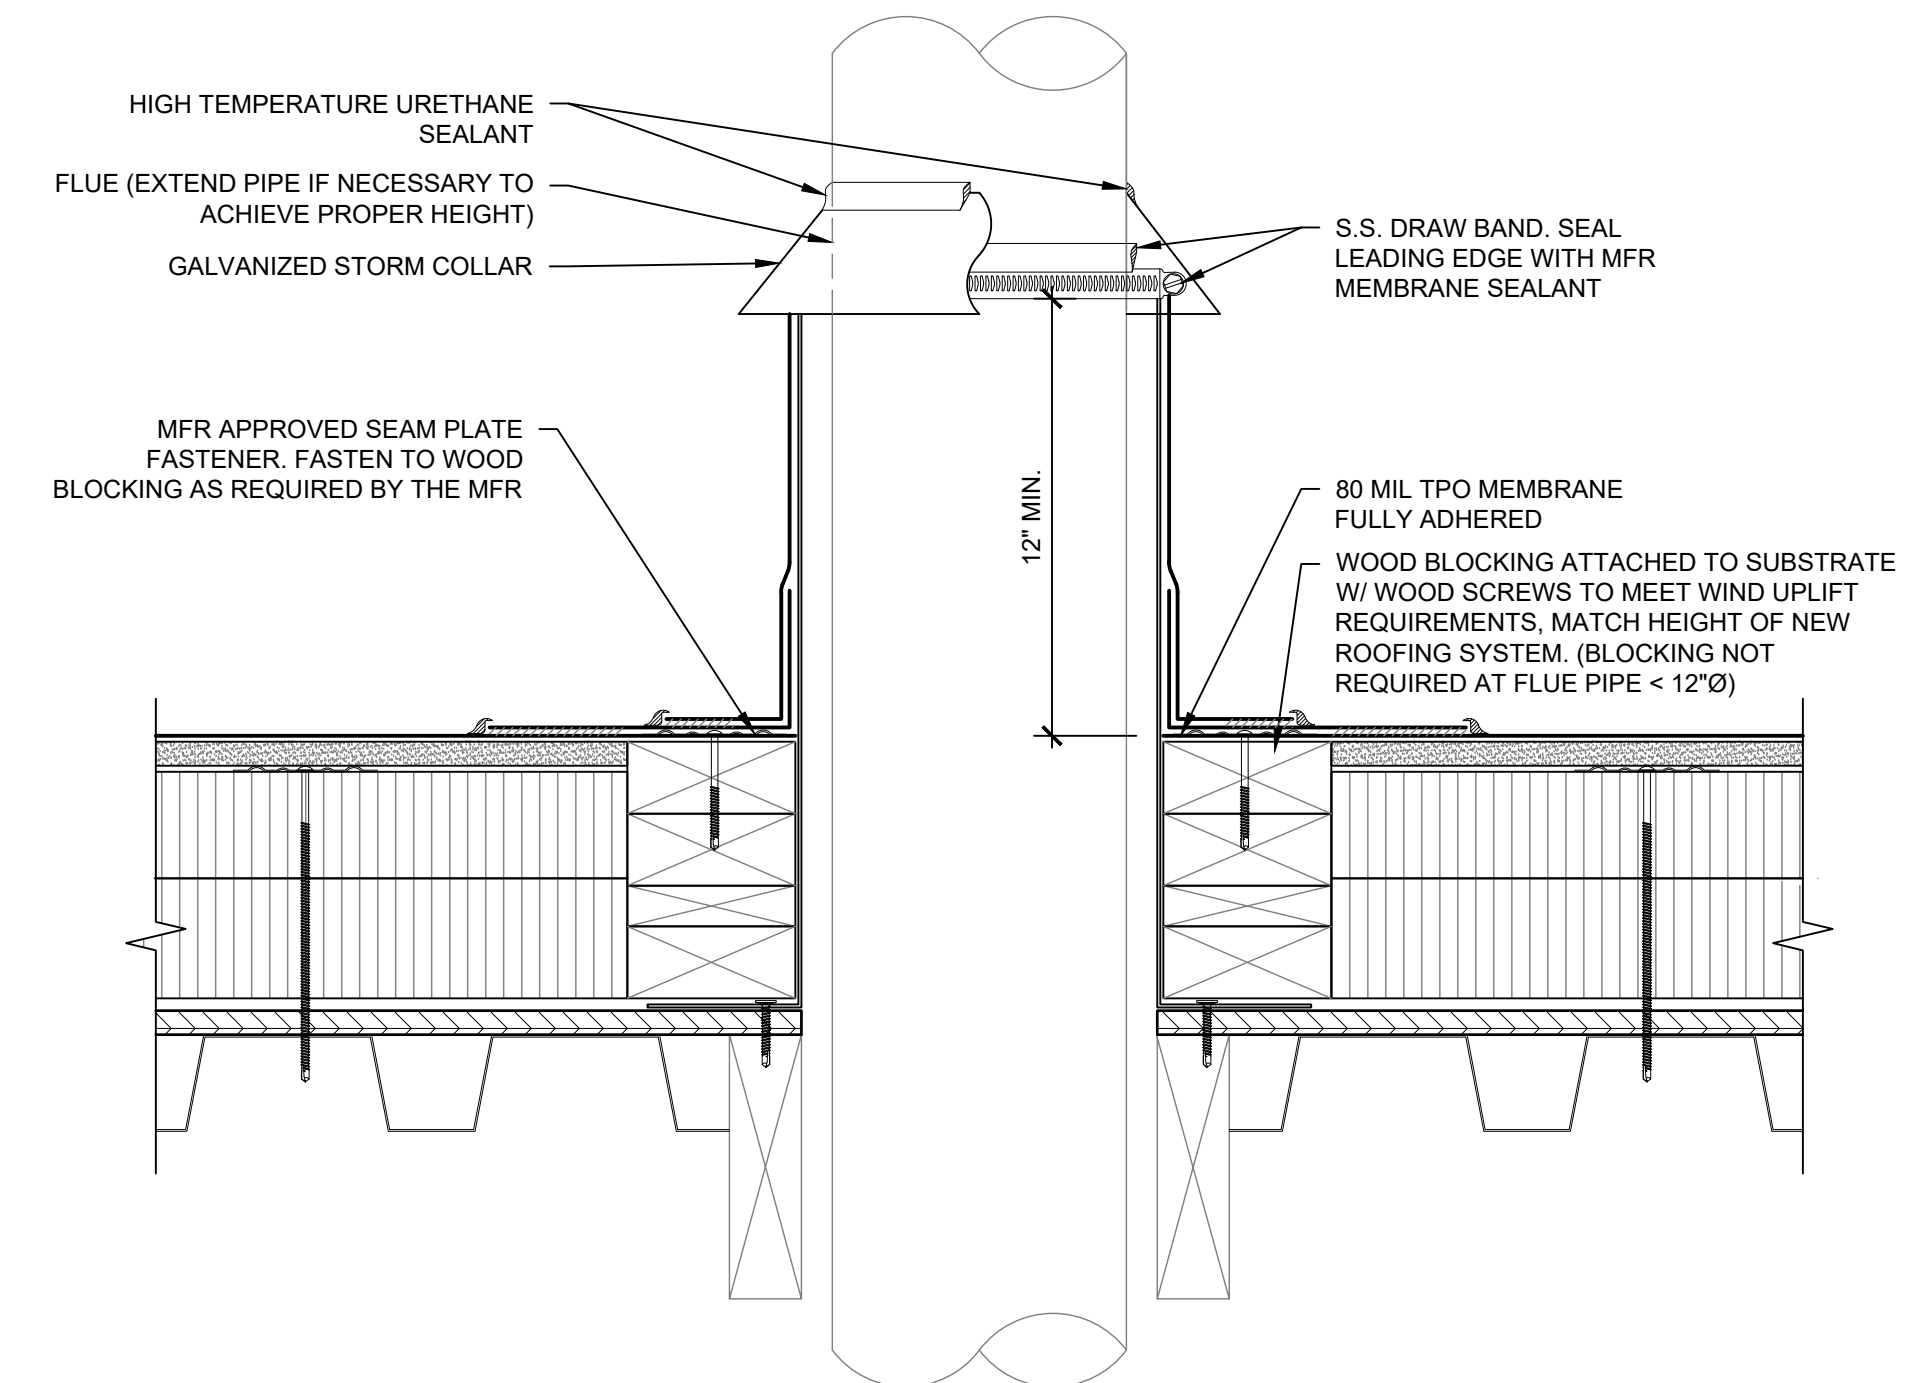
3 Flashing Termination at Flue Pipe > 12" Ø  
SCALE: 3" = 1'-0"

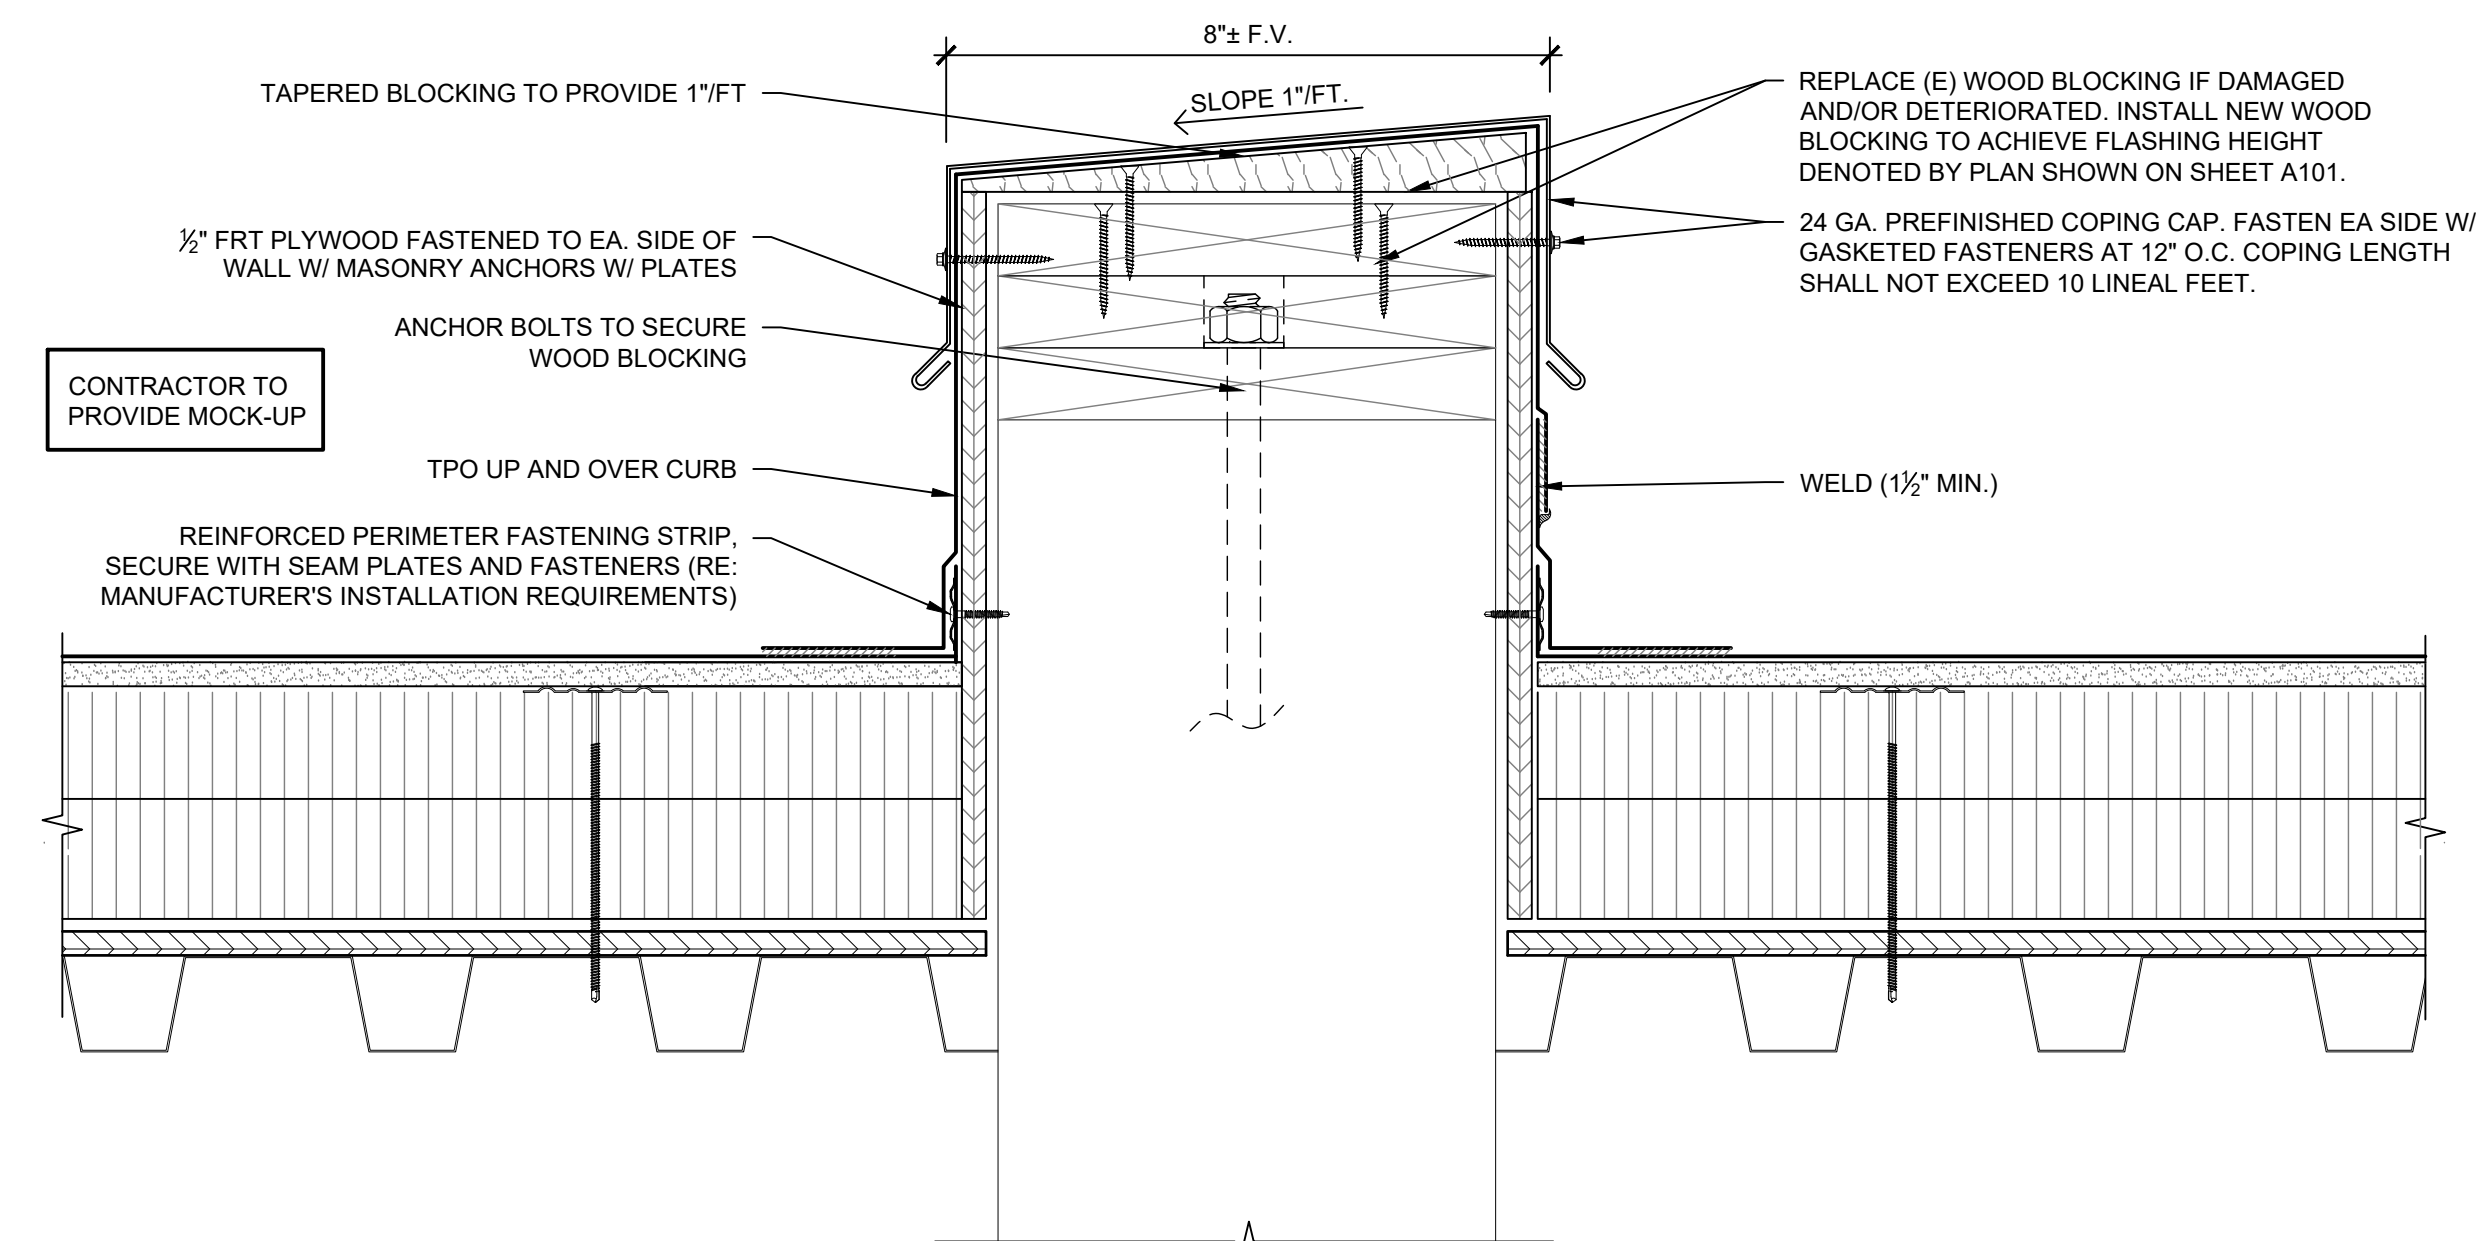
1 Roof Area Divider Curb  
SCALE: 3" = 1'-0"

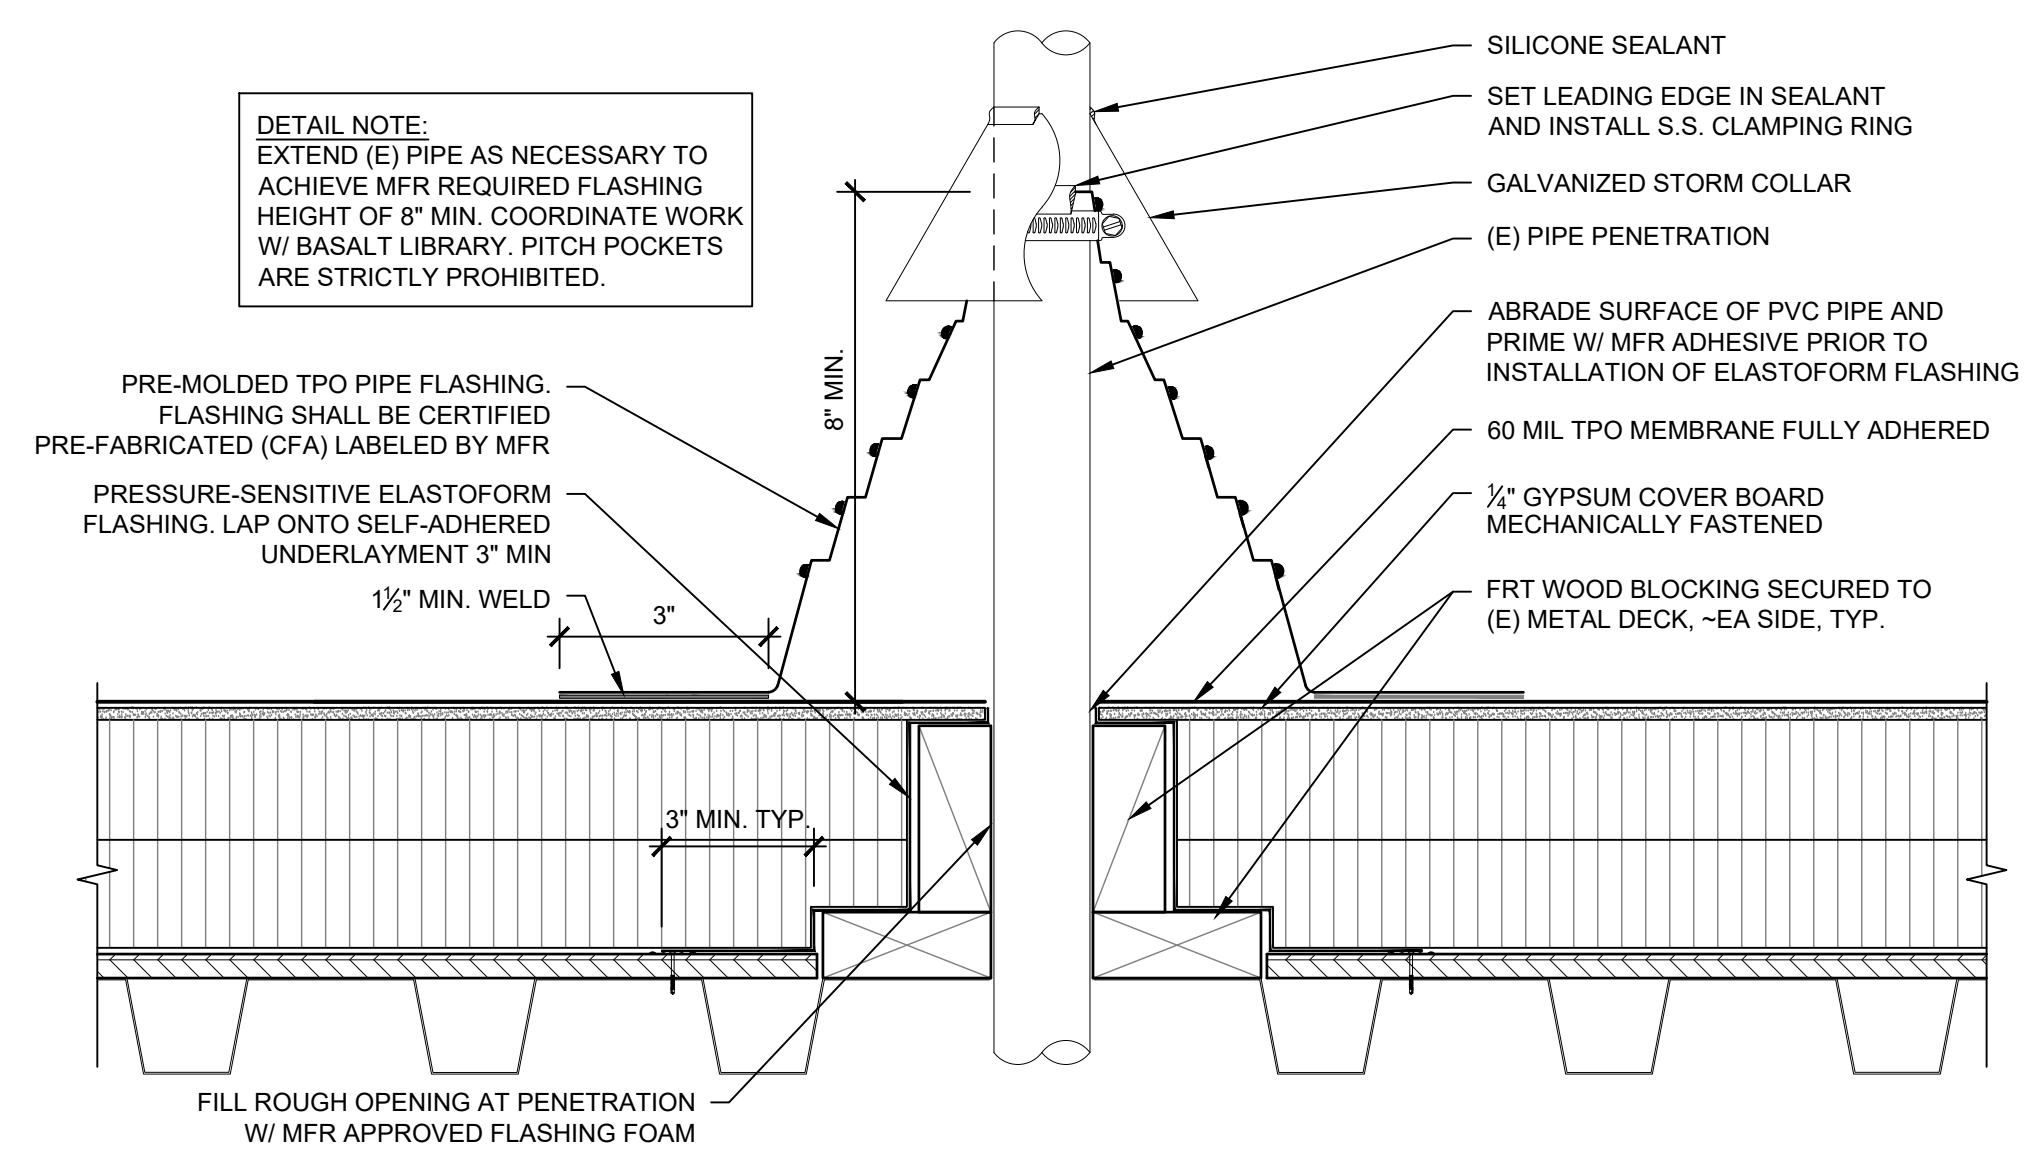
**2 FLASHING TERMINATION AT EXISTING PIPE PENETRATION**  
 SCALE: 3/4" = 1'-0"

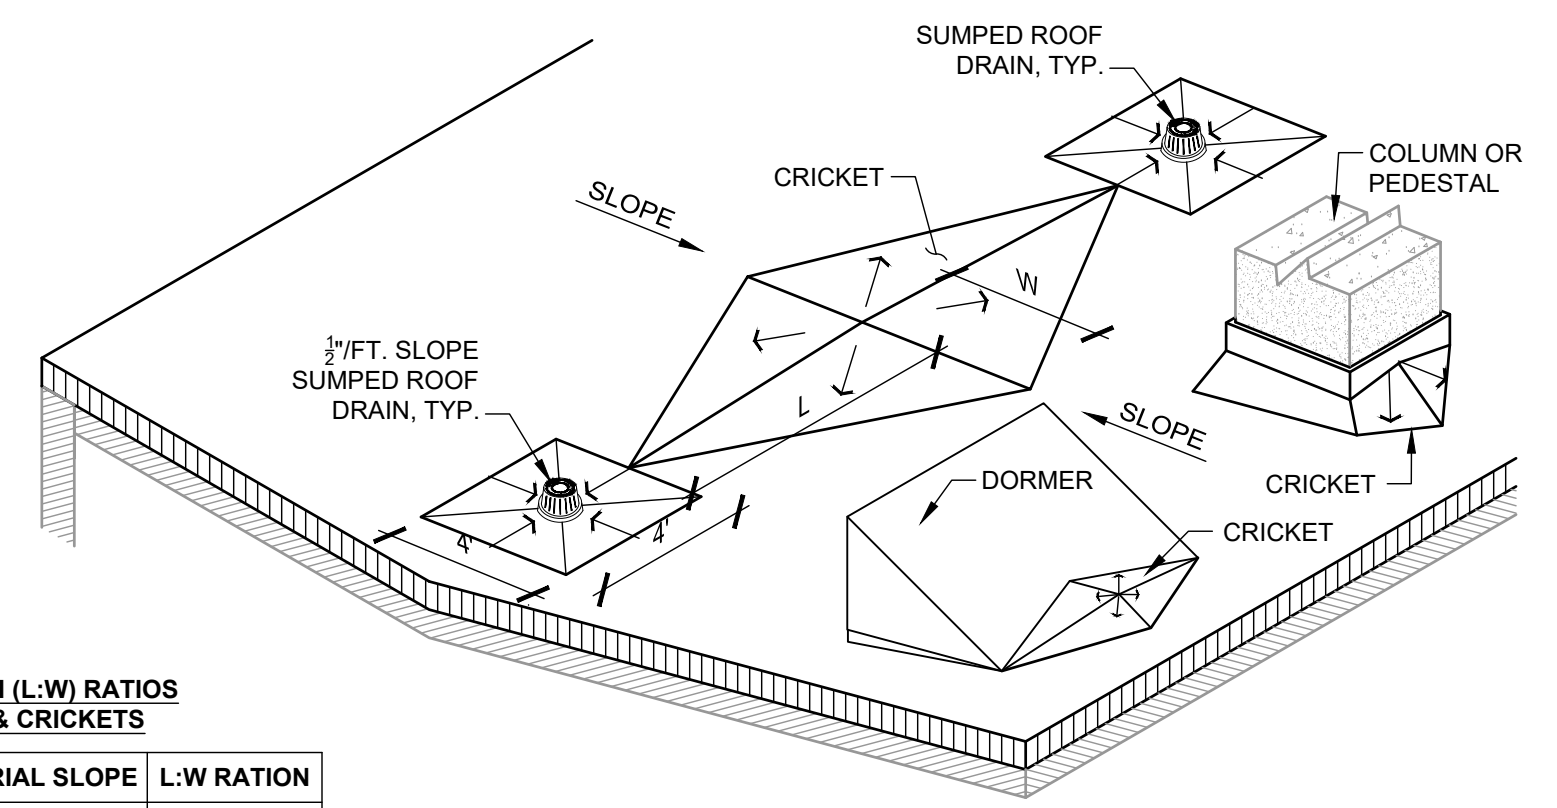
**1 STANDARD TAPERED ISO CRICKET DETAIL**  
 N.T.S.
